## **Appendix 1**

### **Photograph Log**

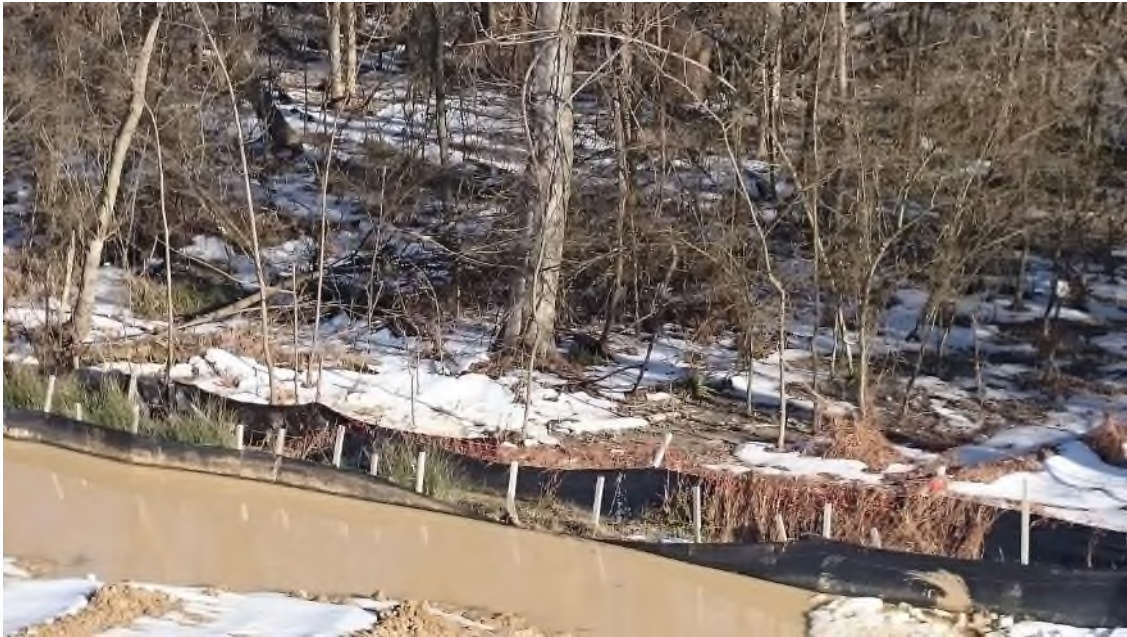
**Photograph 92. Hopewell Regional Wastewater Treatment Plant Construction Site: On the far side of the embankment from Photographs 83-88, showing location of former temporary sedimentation basin 3.**

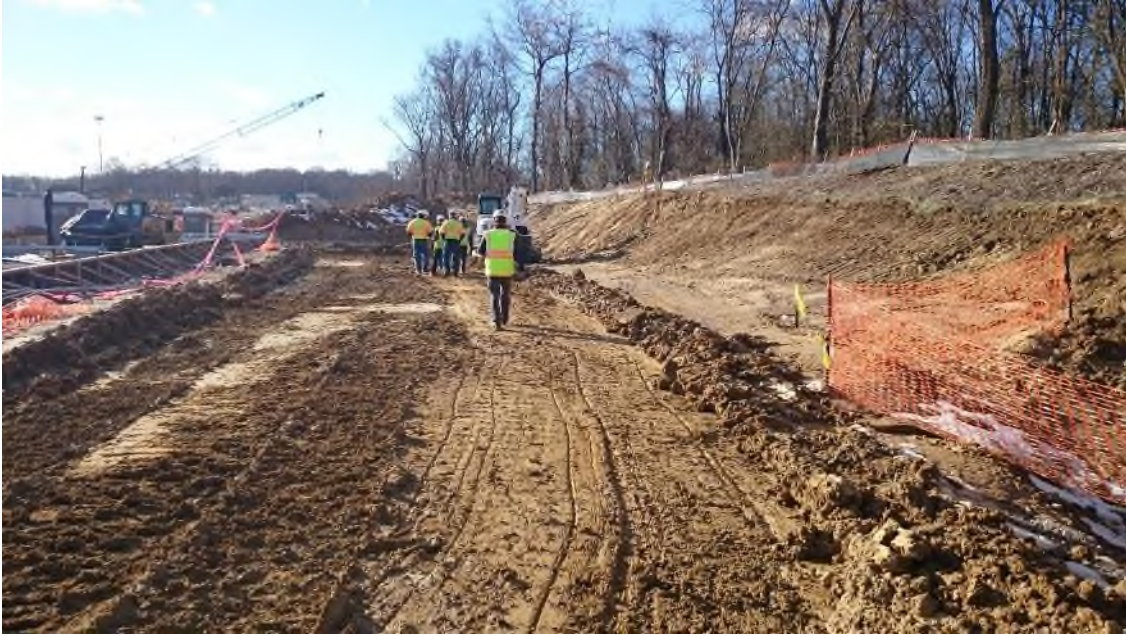
**Photograph 95. Hopewell Regional Wastewater Treatment Plant Construction Site:  
Construction access road with construction embankment to the right.**

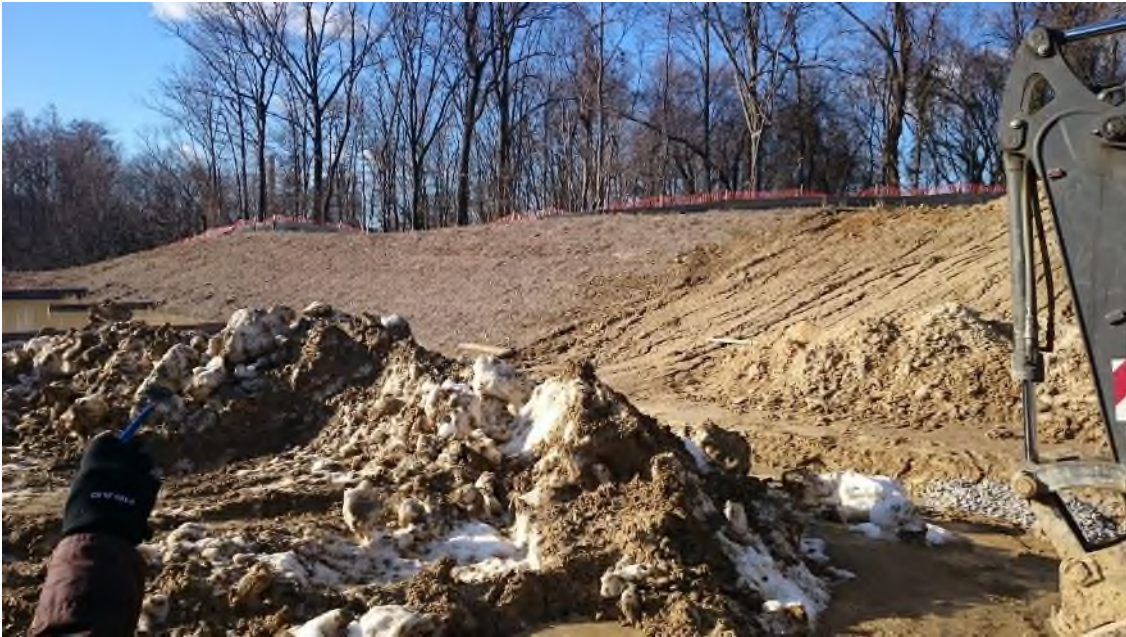
**Photograph 96. Hopewell Regional Wastewater Treatment Plant Construction Site:  
Construction embankment (right) with temporary sediment basin 1 (left background).**

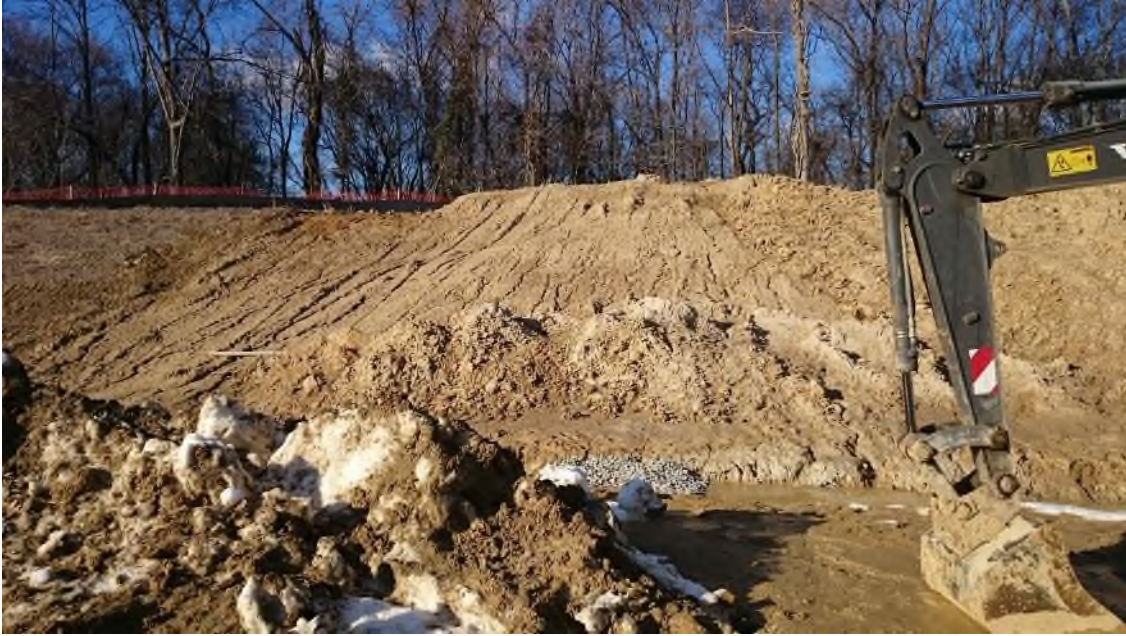
**Photograph 97. Hopewell Regional Wastewater Treatment Plant Construction Site:  
Alternate view of construction embankment.**

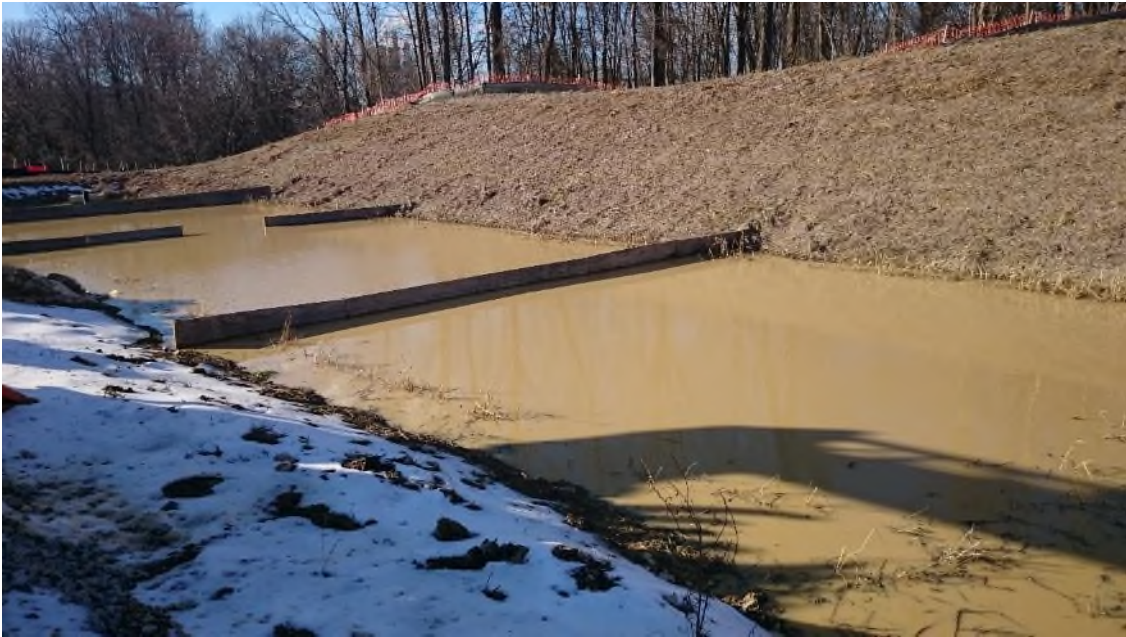
**Photograph 98. Hopewell Regional Wastewater Treatment Plant Construction Site:  
Temporary sediment basin 1 looking downstream.**

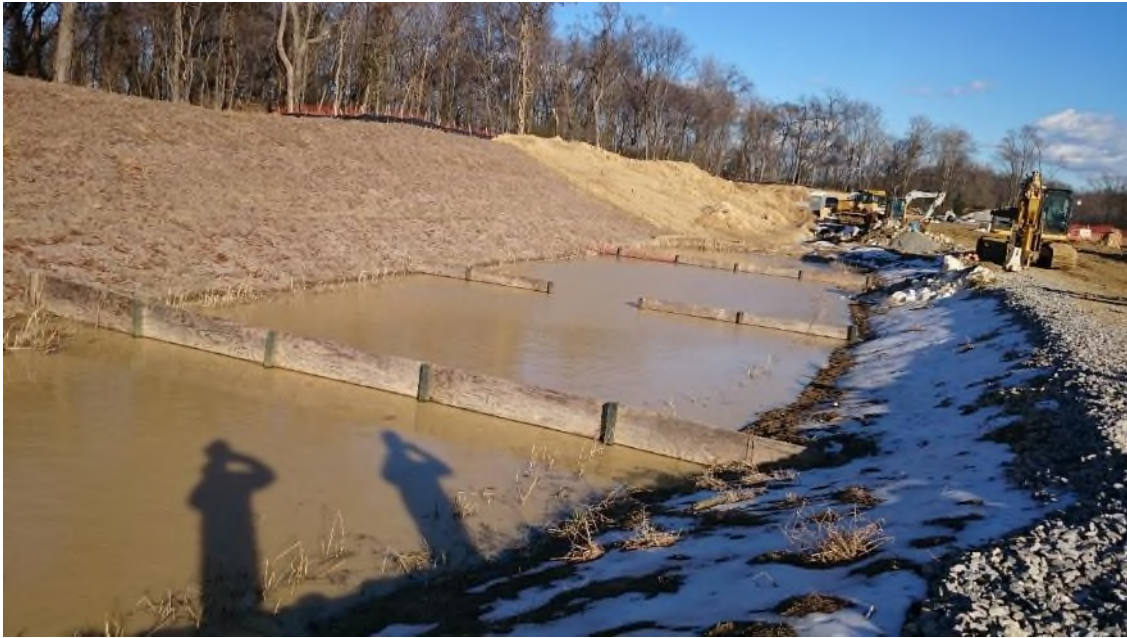
**Photograph 99. Hopewell Regional Wastewater Treatment Plant Construction Site:  
Temporary sediment basin 1 looking upstream.**

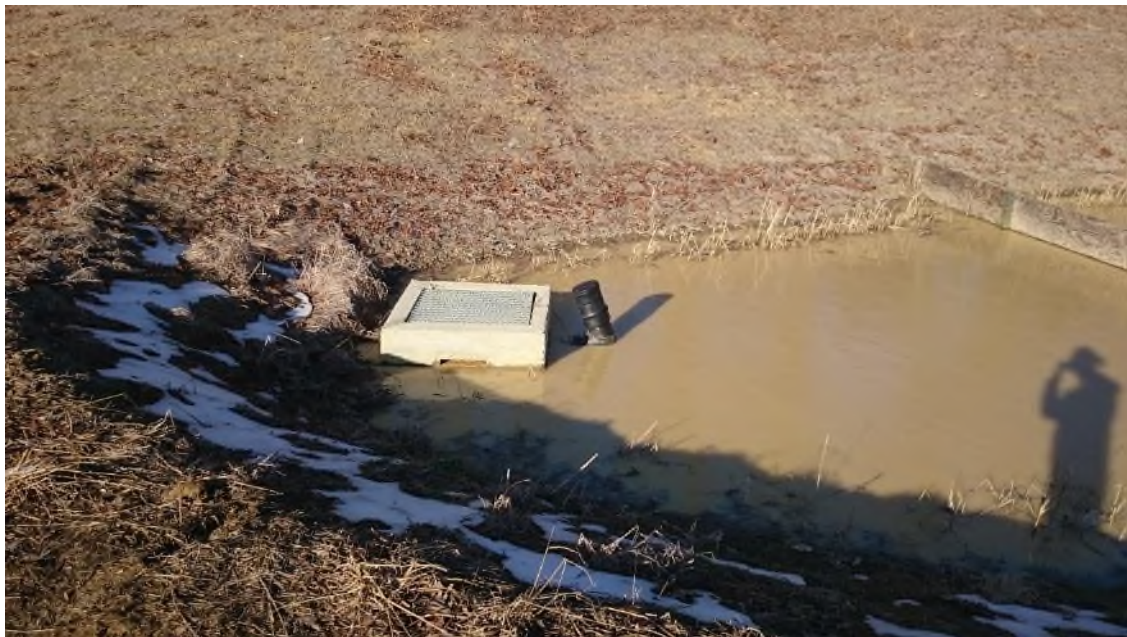
**Photograph 100. Hopewell Regional Wastewater Treatment Plant Construction Site:  
Outfall from temporary sediment basin 1.**

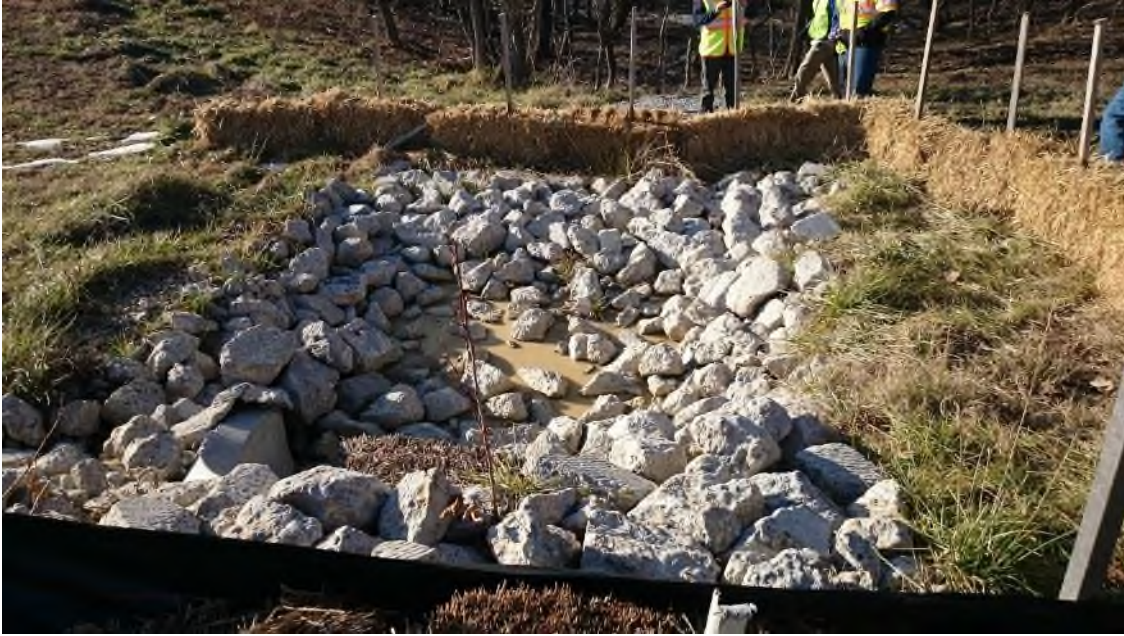
**Photograph 101. Hopewell Regional Wastewater Treatment Plant Construction Site:  
Outfall of temporary sediment basin 1 draining down the hill (background) directly into  
the James River.**

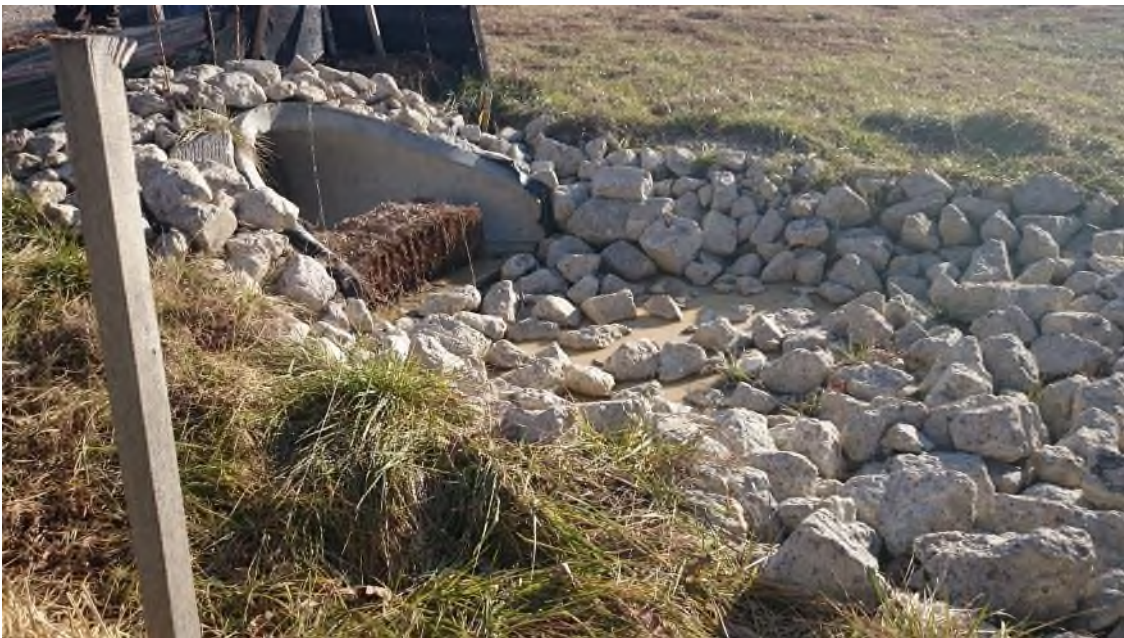
**Photograph 102. Hopewell Regional Wastewater Treatment Plant Construction Site:  
Alternate view of outfall from temporary sediment basin 1.**

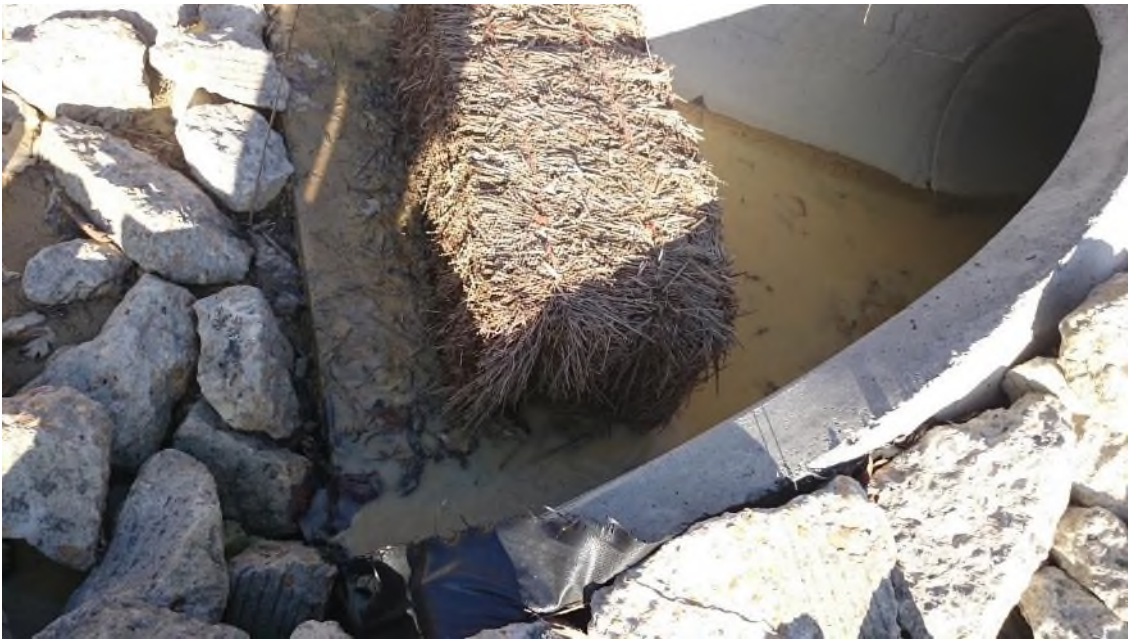
**Photograph 104. Hopewell Regional Wastewater Treatment Plant Construction Site:  
Closer view of outfall of sediment basin 1.**

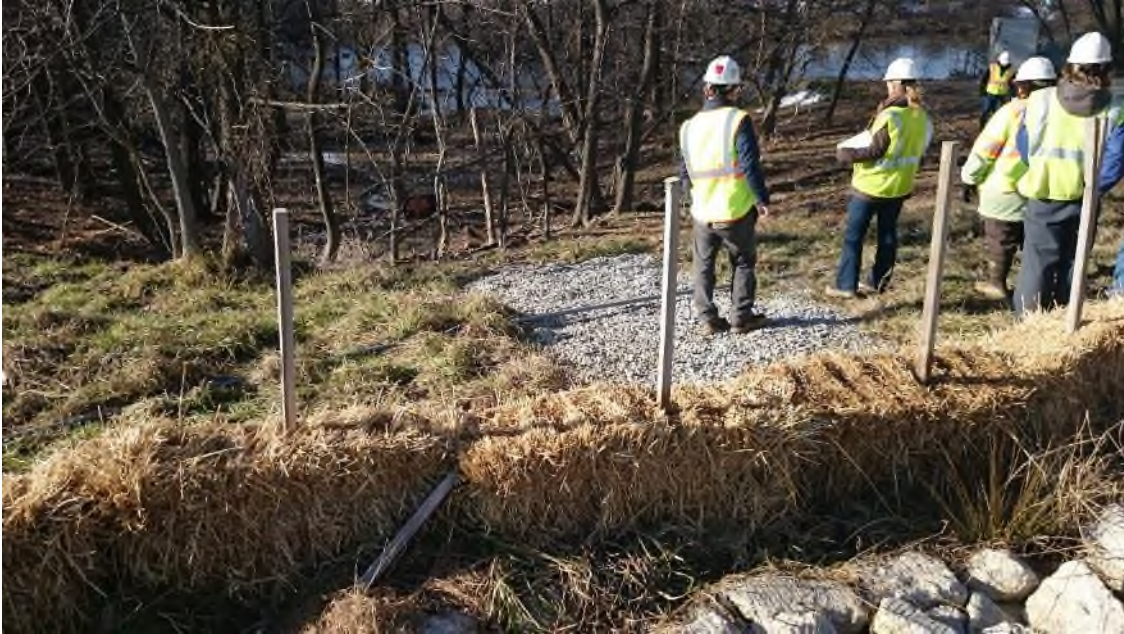
**Photograph 105. Hopewell Regional Wastewater Treatment Plant Construction Site:  
Downhill of outfall pictured in Photographs 101-104 with the James River in the  
background.**

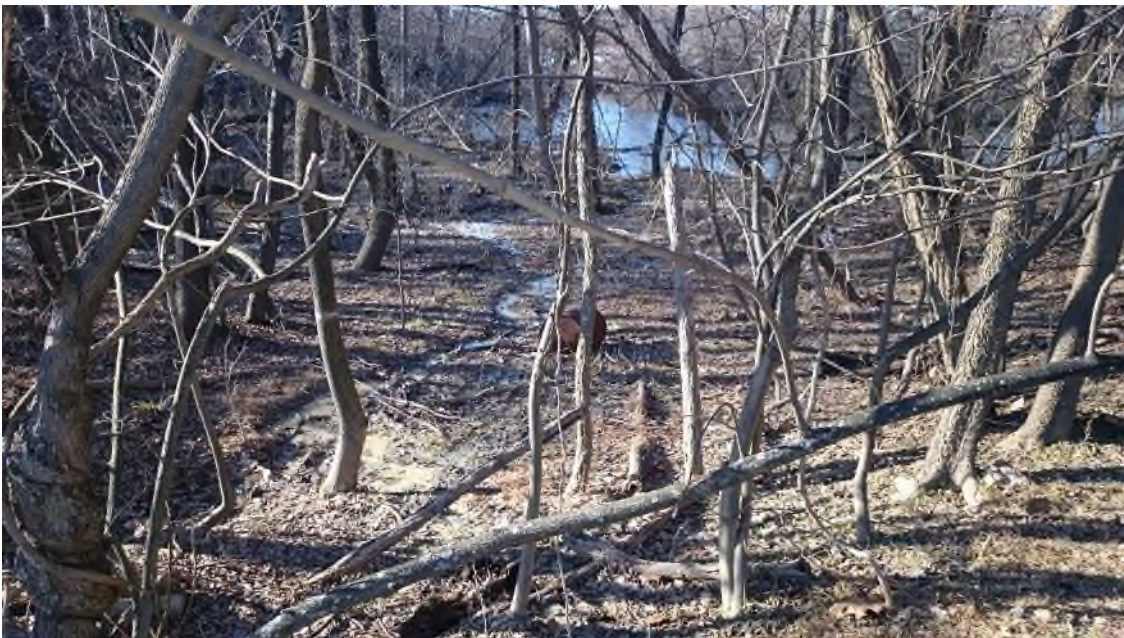
**Photograph 106. Hopewell Regional Wastewater Treatment Plant Construction Site:  
Water flowing downhill of outfall pictured in Photographs 101-104 With the James River  
in the background.**

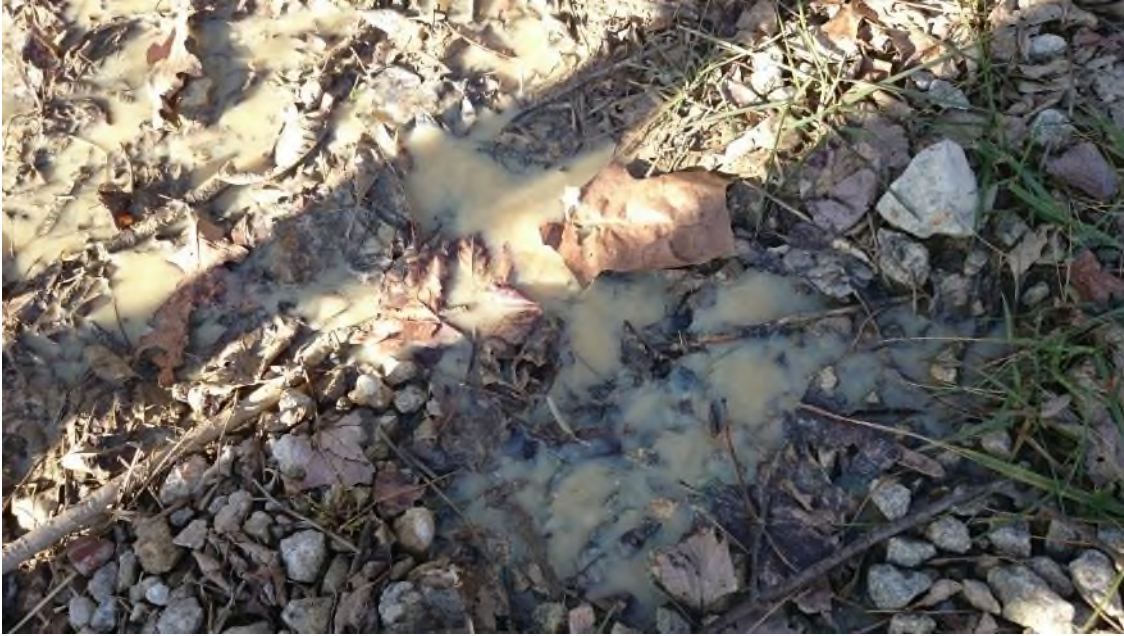
**Photograph 107. Hopewell Regional Wastewater Treatment Plant Construction Site: Close up view of silty water flowing downhill of outfall pictured in Photographs 101-104.**

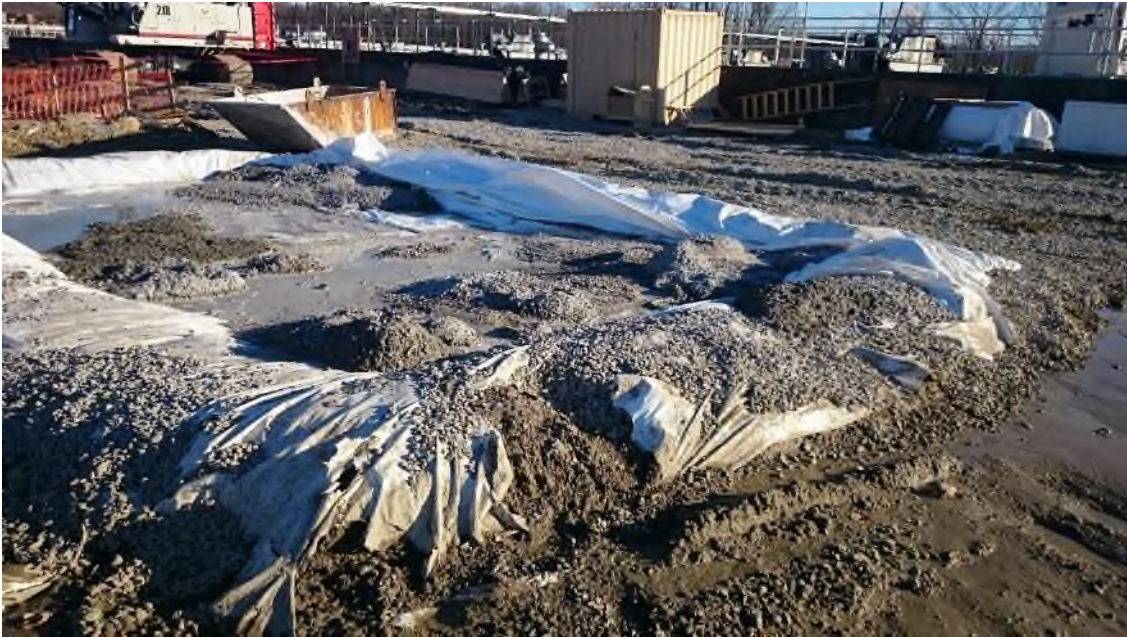
**Photograph 110. Hopewell Regional Wastewater Treatment Plant Construction Site:  
Concrete wash pit.**
